Bulletin Number: 88-7-4
 Reference Number: 877204R
 Publish Date: 10/87

Dealer
 Service
 Bulletin

Subject: FLUID LEAK FROM THE FLUID LEVEL INDICATOR ASSEMBLY BORE

Models Affected: 1988 6000, SUNBIRD, GRAND AM, AND FIERO MODELS EQUIPPED WITH HM-282 MANUAL TRANSAXLE (RPO MG1 AND MG2) 1988 DAS, 8ZP, 8ZR, 8ZN, ZZJ AND 8ZL

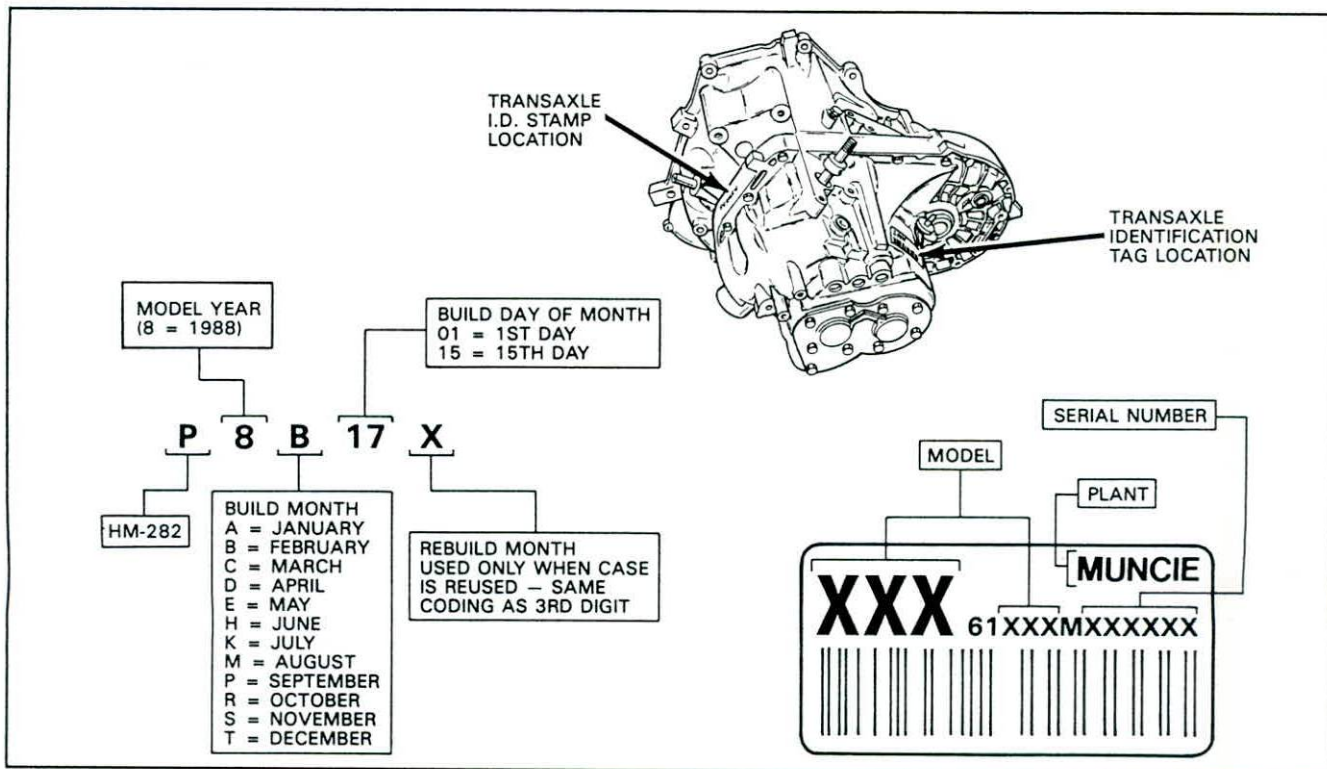
Figure 1 — HM-282 Transaxle Identification Information
 RPO MG1/MG2

Some early 1988 6000, Sunbird, Grand Am, and Fiero models equipped with an HM-282 manual transaxle (RPO MG1 and MG2) may experience a fluid leak from the indicator bore.
